Missouri Highway and Transportation Department.

FLOODS AND HUMAN INTERACTIONS

Effects of Development on Floodplains

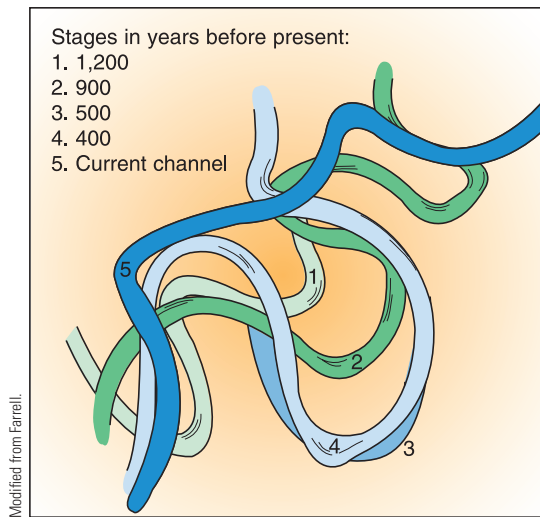
► **FIGURE 12-3.** The Mississippi River at False River, Louisiana, shows gradual migration of meanders before the formation of a cutoff in an oxbow lake. The river flows from upper right to lower left.

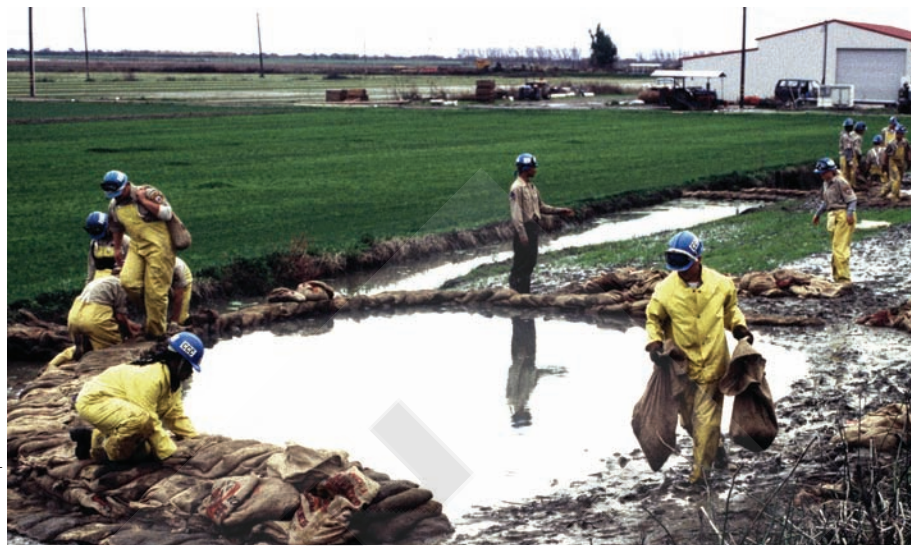
► **FIGURE 12-4.** A California Conservation Corps crew places sandbags around sand boils at the Sacramento River, at north Andrus Island, in the delta area southwest of Sacramento on January 4, 1997.

Rising floodwater in a river increases water pressure in the groundwater below; this can push water to the surface on the floodplain, where it can potentially rise to nearly the water level in the river. With prolonged flooding, that water often reaches the surface as **sand boils** (► Figures 12-2 and 12-4). The water, under pressure, gurgles to the surface to build a broad pile of sand a meter or more across. Workers defending a levee generally pile sandbags around sand boils to prevent the loss of the piped sand (► Figure 12-4). They leave an opening in the sandbags to let the water flow away and reduce water pressure under the levee.

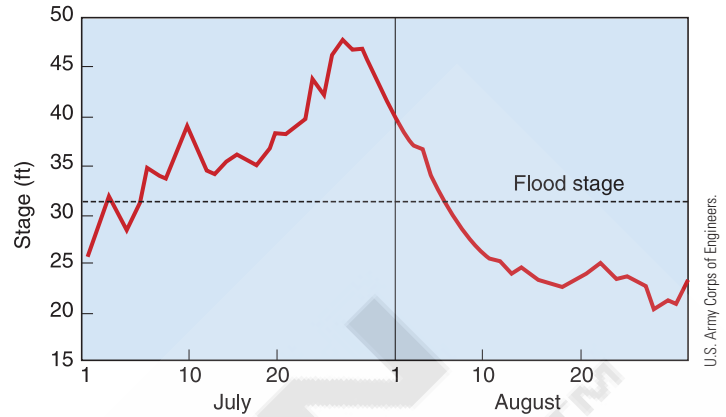
► **FIGURE 12-5.** (a) This map shows the Mississippi basin and the general area of flooding streams during the summer of 1993. Heavily affected states are labeled with their abbreviations. (b) The flood hydrograph for the 1993 flood event shows that the Mississippi River was above flood stage for more than one month.

August 1993 had the largest upper Mississippi flood on record, larger than a 100-year event (► Figures 12-5, 12-6, and 12-7). River flow reached 29,000 cubic meters per second at St. Louis, 160 percent of the average flow at New Orleans near the mouth of the river. Twenty-five thousand square kilometers of floodplain was underwater. Fifty people died, and damages exceeded \$22 billion,* the worst flood disaster in U.S. history. More people died in the previous record flood on the lower Mississippi River in 1927, primarily because flood forecasting and warning systems then were less advanced. In 1993, highways, roads, and railroads were submerged for weeks on end, along with homes, businesses, hospitals, water-treatment plants, and factories (► Figures 12-8 and 12-9). Almost 100,000 square kilometers, much of it productive farmland, lay underwater for months. Wells for towns and individual homes were flooded and contami-

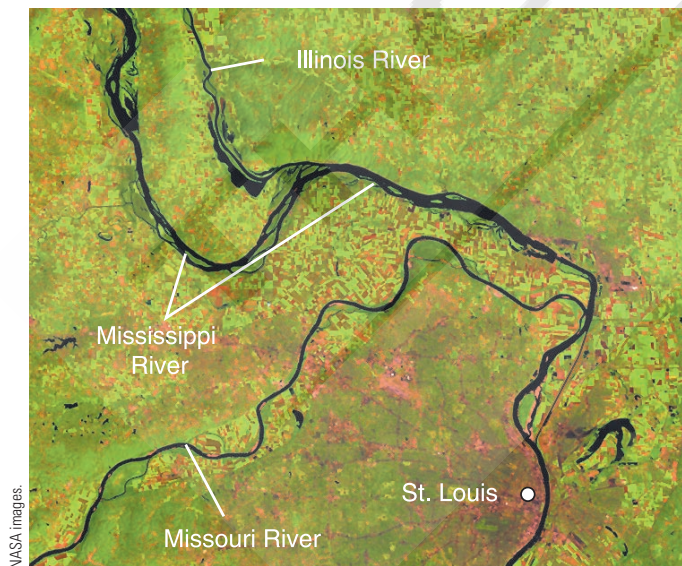
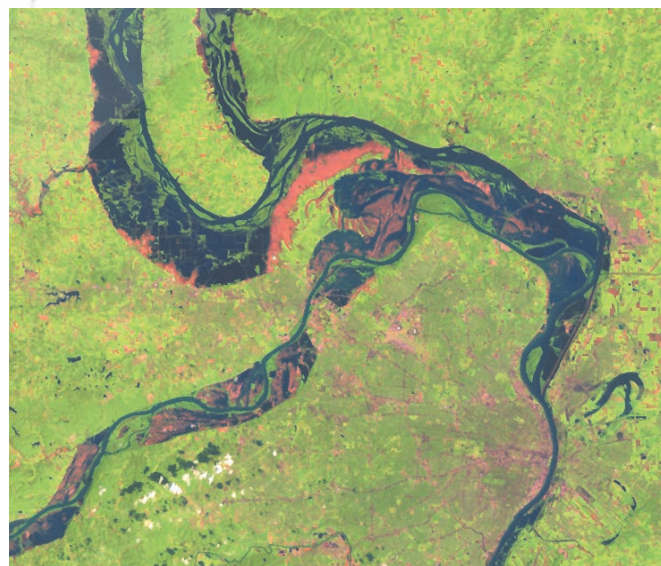
► **FIGURE 12-6.** The Mississippi River flood of 1993 can be clearly seen by comparing satellite images taken (a) before and (b) during the flood. Note that the river fills its floodplain except in the channelized St. Louis reach.

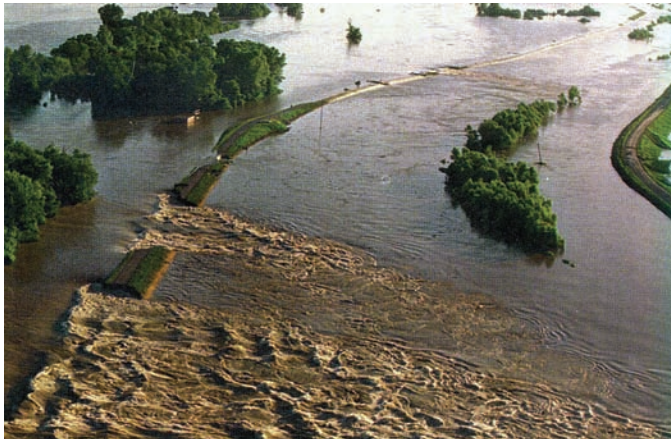
► **FIGURE 12-7.** In the breach of this levee during the 1993 flood on the Mississippi, the river (on the left) spills through two breaches to cover the floodplain (right). A second levee at the right edge of the photo provides temporary relief.

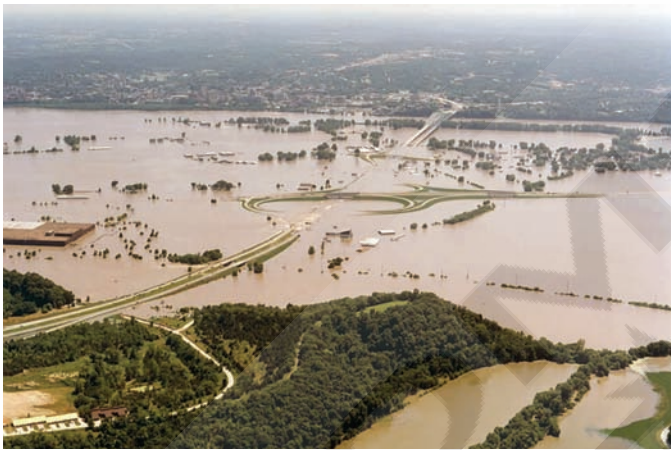
► **FIGURE 12-8.** The Missouri River flooded, filled its floodplain, and submerged this freeway near Jefferson City, Missouri, in late July 1993.

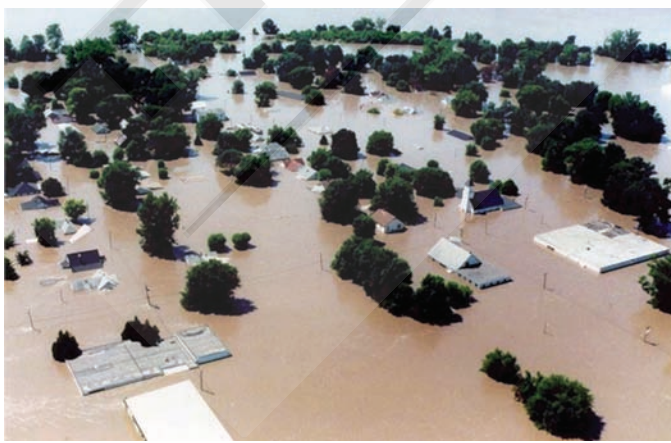
► **FIGURE 12-9.** The 1993 flood left a large number of homes deeply submerged in floodwaters for an extended period of time.

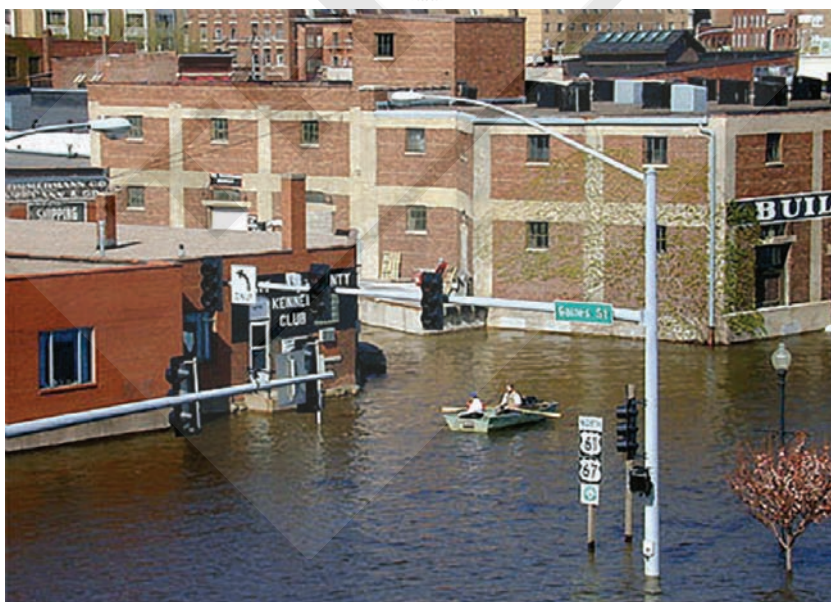
► **FIGURE 12-15.** Davenport, Iowa, also on the Mississippi River floodplain, was again underwater during the 2001 event.

The **National Flood Insurance Program** (NFIP) made insurance available to those living on designated floodplains at modest cost (see “Floodplains and 100-Year Floodplains” in Chapter 11, page 292). In spite of that, only 5.2 percent of households in the Mississippi flood-hazard area had purchased flood insurance; those who did not probably believed that their floodplain property was protected by the levees. Some communities were again flooded in 2001 (► Figure 12-15).

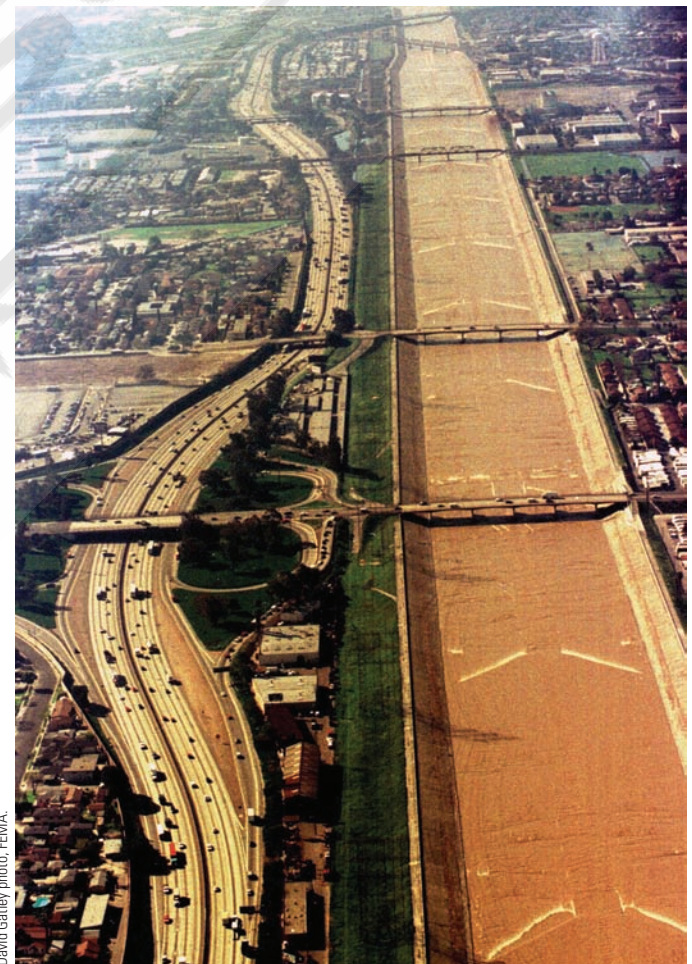
► **FIGURE 12-16.** The Los Angeles River runs through a straight section of concrete channel with angled energy dissipation structures.

ing walls lining rivers that run through them (see “Case in Point: A Channelized Old World River”). In other cases, such as the upper Rhine valley of Germany, levees were constructed to deepen the flow to permit year-round navigation. The intended results were as anticipated. Those walls raised flood water levels and increased the water velocity. Unfortunately, such changes also enhanced erosion, both in the channeled reach and downstream where the river is not confined to the channel. Floods also pass through more rapidly, resulting in much higher downstream flood crests. Urban Los Angeles provides an extreme example of **channelization** (▶ Figure 12-16).

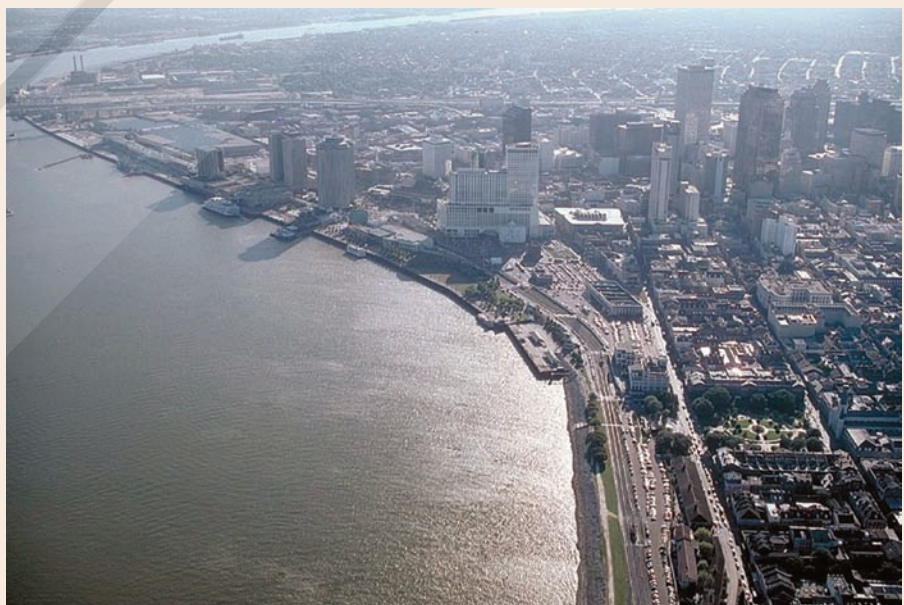
▶ **FIGURE 12-21.** New Orleans, the major shipping center on the lower Mississippi River, is protected by levees so that the river now stands 4 meters above the downtown area.

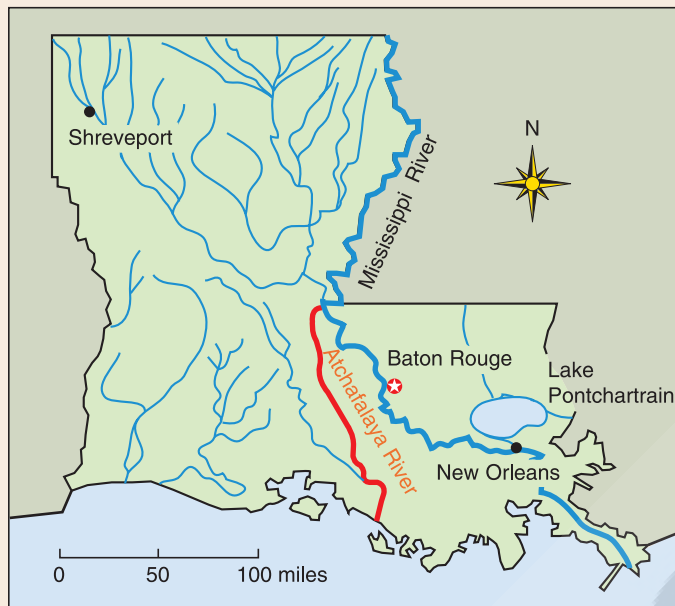
► **FIGURE 12-22.** In Louisiana, the Mississippi River takes a long gentle path to the Gulf of Mexico. The Atchafalaya River drains part of the flow of the Mississippi upstream from Baton Rouge, taking a shorter and therefore steeper path.

As the Mississippi River carries sediment to the Gulf of Mexico, it builds its delta seaward, thereby decreasing the river's slope in the depositional delta area. At the same time, the river builds both its bed and natural levees higher. During a major flood, the river breaches the natural levees, and its water heads down a steeper, shorter, lateral path to the sea. Because water flows faster on the steeper slope, it will begin to carry more of the river's flow, gradually taking over to become the new main channel. Sixty to seventy years ago, a new distributary channel, the Atchafalaya River, formed and began to sap some of the flow from the main channel (▶ Figure 12-22).

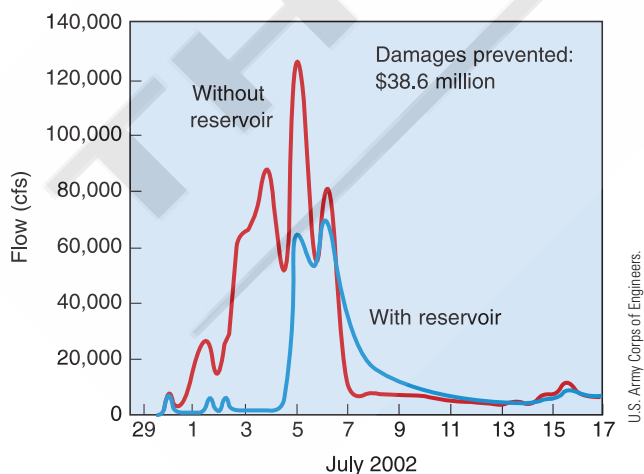
▶ **FIGURE 12-23.** This flood hydrograph shows the Guadalupe River with Canyon Lake Reservoir (blue) and a calculation of what it would have been without the reservoir (red).

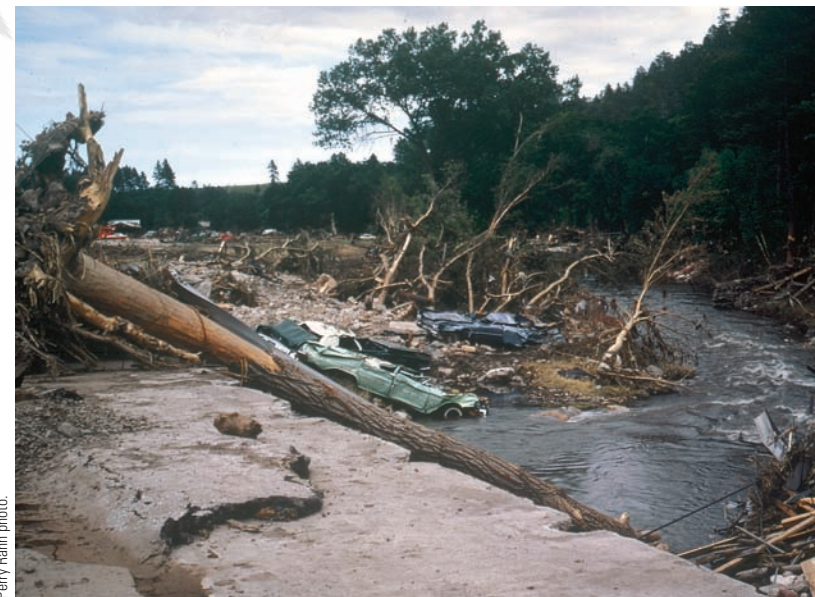
▶ **FIGURE 12-24.** Damages from the June 10, 1972, flood at Rapid City, South Dakota, were extensive. Cars were mangled, and all that is left of a nearby house is the tangle of boards in the lower right.

Flooding on Rapid Creek in the Black Hills of South Dakota provided dramatic evidence of why it is dangerous to live downstream of a multiuse dam (▶ Figure 12-24). In just six hours in June 1972, 37 centimeters of rain fell over the Rapid Creek drainage basin. Southeast winds carrying warm, moist air from the Gulf of Mexico banked up against the Black Hills where it encountered a cold front from the northwest. Pecola Dam, 16 kilometers upstream, was built on Rapid Creek just twenty years earlier for irrigation and flood control after an earlier flood. Building of this and other dams made people feel secure from floods, so they built homes along the creek downstream.

During the intense flood of 1972, the creek's typical flow of a few cubic meters per second became a torrent of 1,400 cubic meters per second within a few hours. With rising water, authorities began ordering evacuation of the low-lying area close to the creek at 10:10 P.M., and the mayor urged evacuation of all low-lying areas at 10:30. The spillway of a dam just upstream from the city became plugged with cars and house debris from upstream, raising the lake level by 3.6 meters. At 10:45 P.M. the dam failed, releasing a torrential wall of water into Rapid Creek that flows through Rapid City. The flood just after midnight killed 238 people, destroyed 1,335 homes and 5,000 vehicles, and caused \$690 million in damages. More than 2,800 other homes suffered major damage (▶ Figures 12-24 and 12-28).

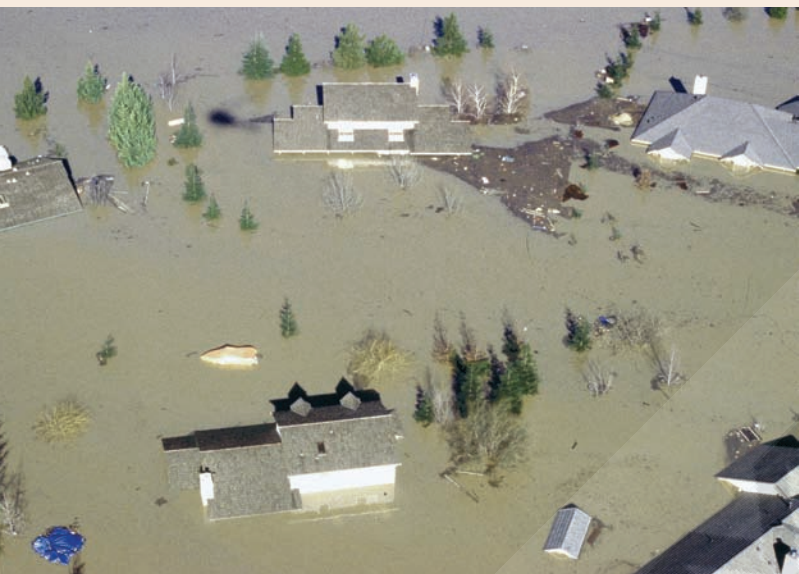
► **FIGURE 12-25.** Failed Feather River levees left only rooftops of homes showing above floodwaters on the floodplain north of Sacramento on January 4, 1997.

The worst event of the flood was failure of a problem-plagued levee on the lower Feather River, out on the broad Sacramento River valley, where water rose to a depth of 23.5 meters during the night of January 2. This flooded 39 square kilometers of farmland, killed three people, displaced 80,000 more, and caused \$225 million in damages (► Figures 12-26 and 12-27). The disaster would have been much worse if the new city of Plumas Lakes that was approved in 1993 had been built. Developers and politicians planned it on the floodplain as a Sacramento bedroom community for as many as 30,000 people. By 2001, the Plumas Lakes development had all the basic approvals for an initial 700 homes. All of these sites were partly or entirely flooded in the 1997 storm.

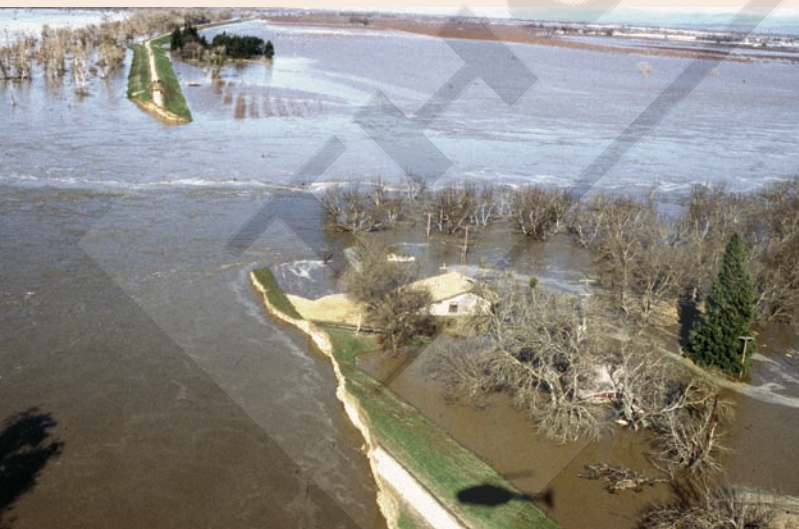
► **FIGURE 12-26.** A levee of the Feather River was eroded and breached at a country club north of Sacramento, California, on January 3, 1997.

Levees failed on the Cosumnes, Mokelumne, Tuolumne, and Feather rivers (► Figure 12-26). The Mokelumne River levee failure swept a marina and 230 boats downstream to crash into a bridge. Multipurpose reservoirs filled up, and erosion and mudslides severed U.S. Highway 50 across the Sierra Nevada in five places. Floodwaters covered 650 square kilometers, killed at least eight people, damaged or destroyed 16,000 homes, and caused damages of more than \$1.8 billion (in 2002 dollars).

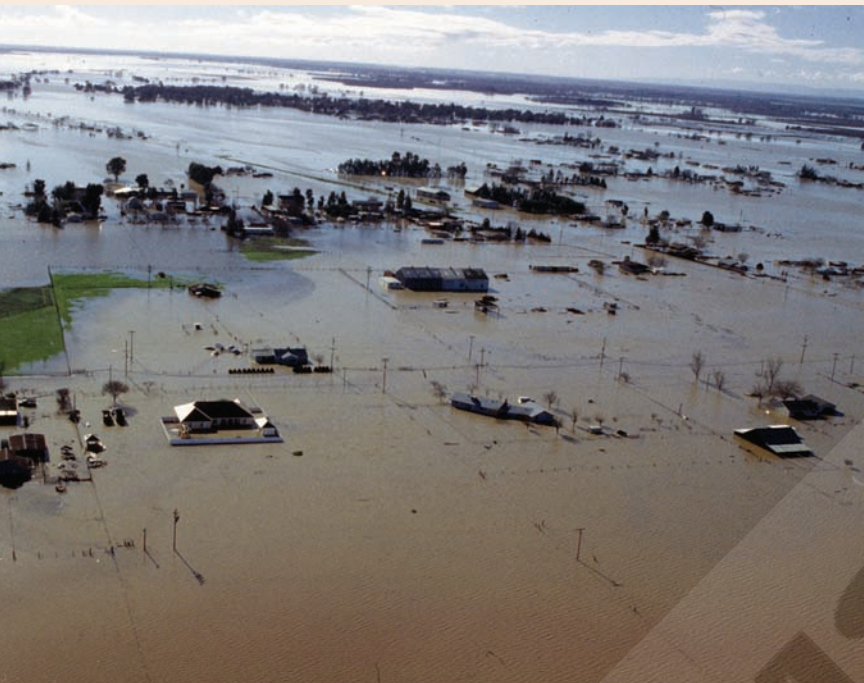
► **FIGURE 12-27.** Flooding from the Feather River extended far off to the horizon in some places.

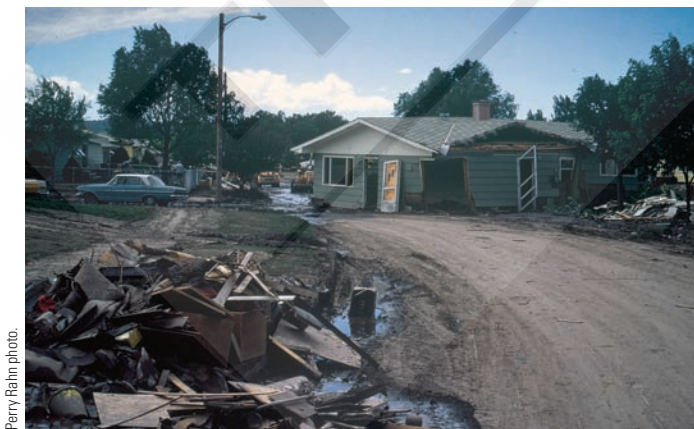
▶ **FIGURE 12-28.** This house was carried off its foundation onto the road by the 1972 Rapid City flood.

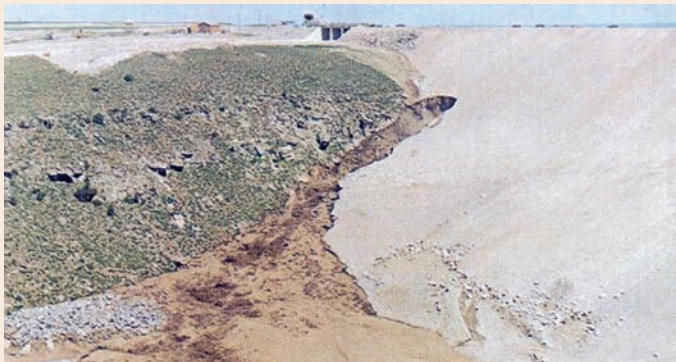
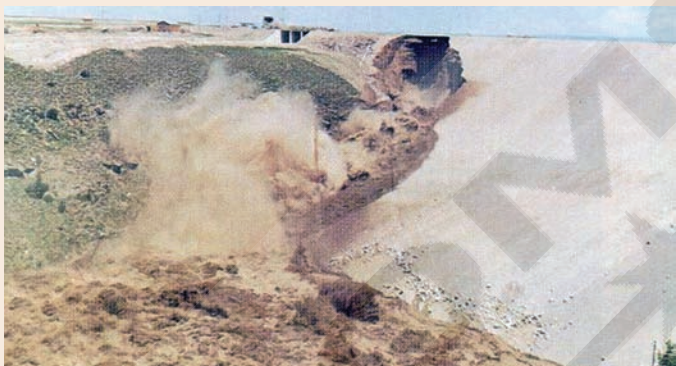
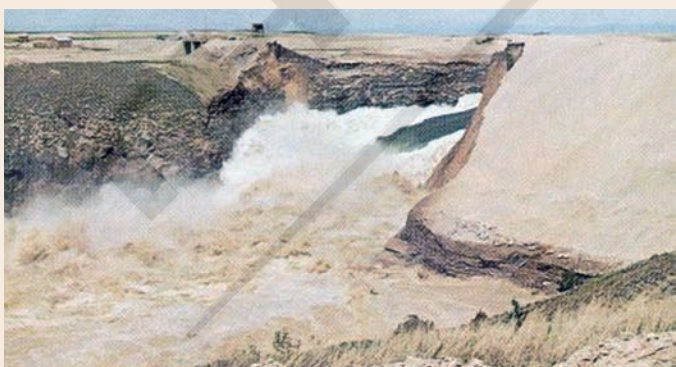
► **FIGURE 12-29.** Progressive failure of Teton Dam, eastern Idaho, June 5, 1976: **(a)** At 11:20 A.M., muddy water pours through the right abutment of the dam. **(b)** At 11:55 A.M., the right abutment begins to collapse and a large volume of muddy water pours through the dam. **(c)** In the early afternoon, the dam fails and the reservoir floods through it.

On June 3, 1976, workers discovered two small springs just downstream from the dam. On June 5 at 7:30 A.M., a worker discovered muddy water flowing from the right abutment (viewed downstream). Although mud in the water indicated it was carrying sediment, project engineers did not believe there was a problem. By 9:30 A.M., a wet spot appeared on the downstream face of the dam and quickly began washing out the embankment material. The hole expanded so rapidly that two bulldozers trying to fill it could not keep up and were themselves lost into the hole. At 11:15 A.M., project officials told the county sheriff’s office to evacuate the area downstream. At 11:55, the crest of the dam collapsed; two minutes later, the reservoir broke through and rushed downstream (► Figure 12-29). The flood obliterated two small towns and spread to a width of 13 kilometers over Rexburg, with a population of 14,000, and continued downslope at 16 to 24 kilometers per hour.

An expert’s review panel blamed design and construction flaws for the dam’s failure. A modern dam was built on bedrock with open joints that were not cemented as specified. Fill settled away from the cracked rock, causing internal deformation of the structure. A concrete wall inside the dam, which was designed to block water flow, was built too thinly and cracked under the high water pressure at the base of the dam.

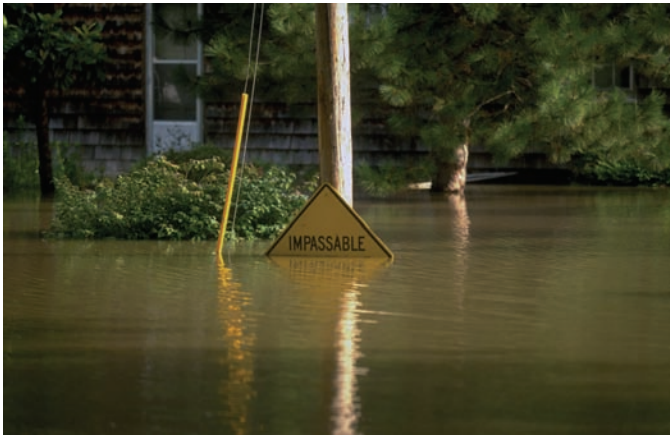
► **FIGURE 12-30.** This flood in the Midwest in June 1994 certainly made roads impassible.

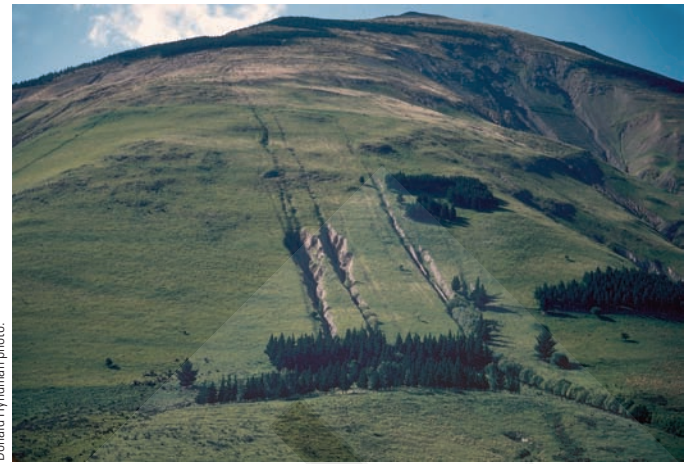
► **FIGURE 12-32.** Heavy sheep grazing has encouraged deep erosion in a steep slope south of Lake Wakatipu, New Zealand. The broader valley in the upper right is a more extreme stage of the same process.

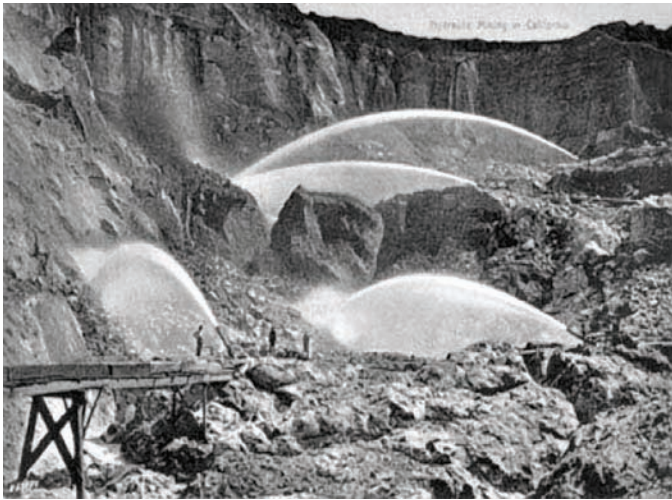
► **FIGURE 12-33.** Hydraulic placer gold mining in California in the 1860s contributed to heavy gravel accumulations in the rivers of the western Sierra Nevada mountain range.

The historic practice of hydraulic placer mining in California during the 1860s and 1870s provided a classic case history of how rivers respond to large volumes of added sediment load. Gold miners originally panned gold or separated it from sand and gravel in streambeds with small sluice boxes fed by water diverted from the stream. As those river gravels became depleted, the miners discovered gold in high-level terrace gravels above the streams. To separate that gold, they used high pressure jets of water from higher elevations to hose down the gravels into large sluice boxes at stream level (► Figure 12-33). The accumulated loose gravel was picked up by the streams during flood and washed down-

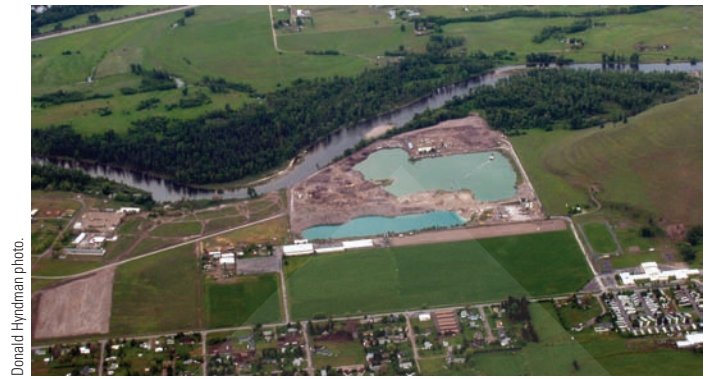
► **FIGURE 12-36.** Now flooded, these gravel pits along the South Platte River near Denver, Colorado, are only separated from the river by thin gravel barriers.

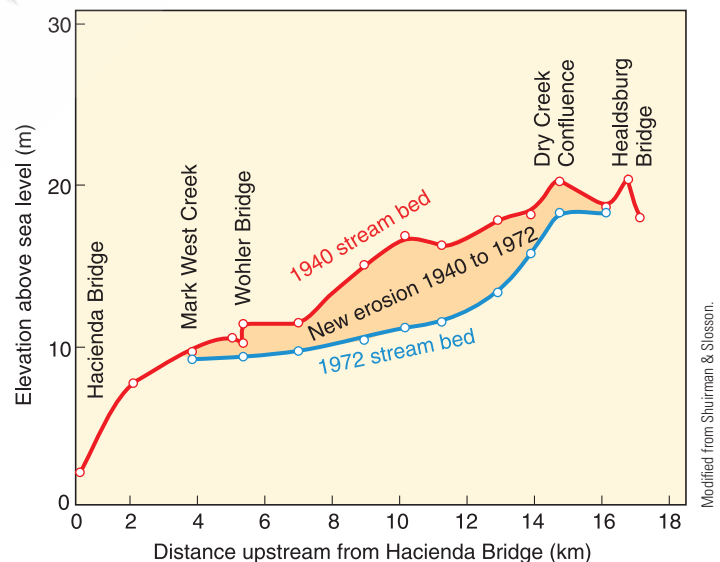
► **FIGURE 12-37.** Downcutting of part of the Russian River channel between 1940, before gravel mining began, and 1972 as a result of gravel-mining operations downstream along the Russian River in northern California.

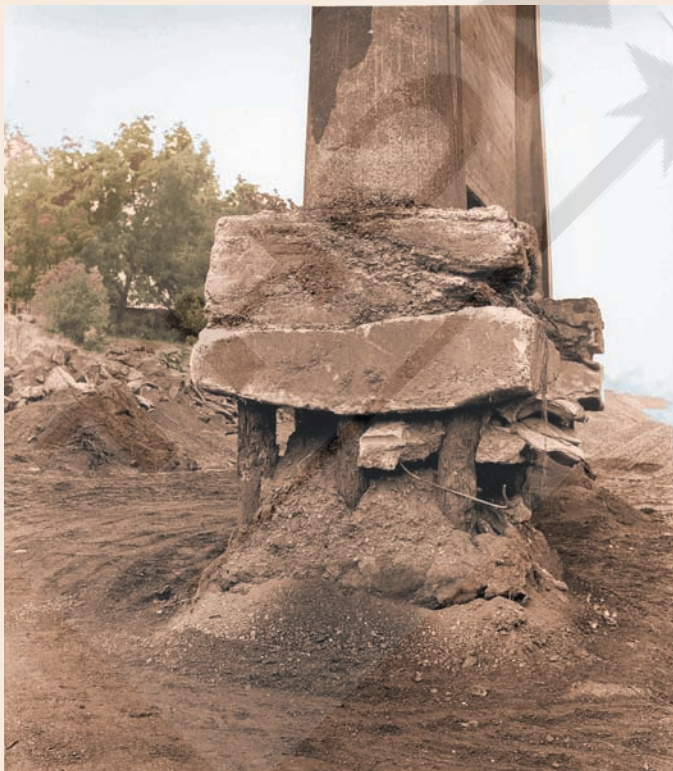
▶ **FIGURE 12-40.** Dry Creek bridge supports near Healdsburg, California, have been severely undercut by stream-bed gravel mining downstream.

Local farmers blamed the gravel miners for the increased erosion and filed suit for damages. Detailed stream studies followed that eliminated large storms, fire or flood events, and land use changes as causes for the observed increase in discharge and erosion. The total deepening of the Russian River streambed upstream from its confluence with Dry Creek ranged, by 1972, from 2 meters at the confluence to 5.7 meters some 5 kilometers upstream and 2 meters some 9 kilometers upstream. Dry Creek eroded its bed 3.3 meters deeper for some 10 kilometers upstream from the confluence (▶ Figure 12-37). It also undercut and threatened bridge supports (▶ see Figure 12-40).

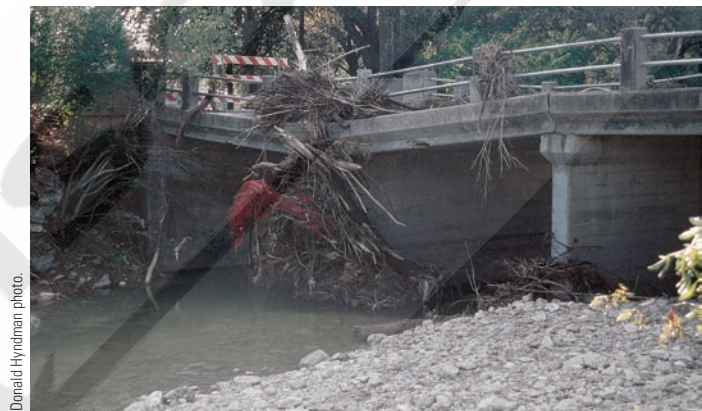
► **FIGURE 12-42.** A catastrophic flood on this small stream, Shoal Creek, in Austin, Texas, on November 15, 2001, overtopped the bridge deck and left branches tangled in its railings, evidence of the previous flood height. The high water also deeply eroded the channel and undercut the supports, causing the bridge deck to sag.

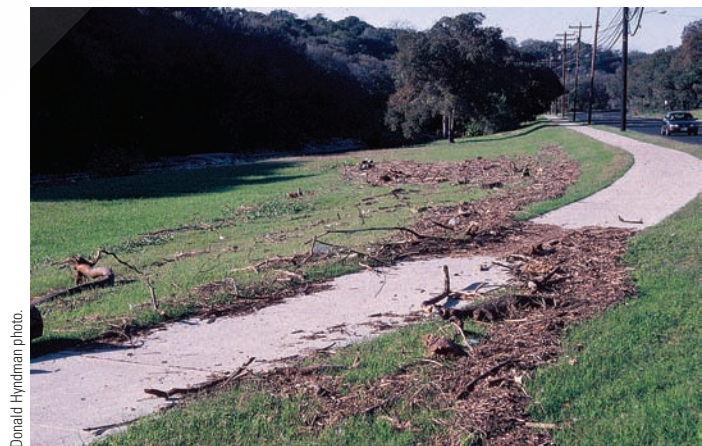
► **FIGURE 12-43.** This organic drift line marks the high water along Shoal Creek in Austin, Texas, from a flood that followed an intense rain storm that dropped 7.5 centimeters of rain in one and one-half hours.

DRIFTWOOD AND SILT LINES Organic debris including leaves, twigs, logs, and silt carried in floodwaters tends to collect at the edges of the flow, including in back eddies (► Figure 12-41). These provide perhaps the best evidence for maximum flood height, though they may not be preserved long after the flood and driftwood is likely to be well below the maximum water level. Debris may pile up on bridges, providing a minimum height of the flood (► Figure 12-42). More commonly, floods will leave behind drift lines that show the high-water mark for a short period of time until it erodes away with the next rainstorm (► Figure 12-43).

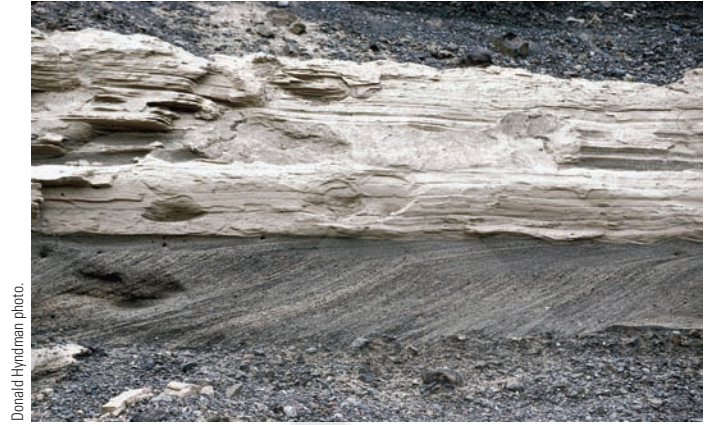
► **FIGURE 12-45.** These Lake Missoula slack water sands were deposited over coarse, darker cross-bedded Lake Missoula flood deposits near Starbuck in eastern Washington state.
